# CLARINDA COMMUNITY SCHOOL DISTRICT

FACILITY CONDITION ASSESSMENT  
February 19th, 2018

## EXECUTIVE SUMMARY

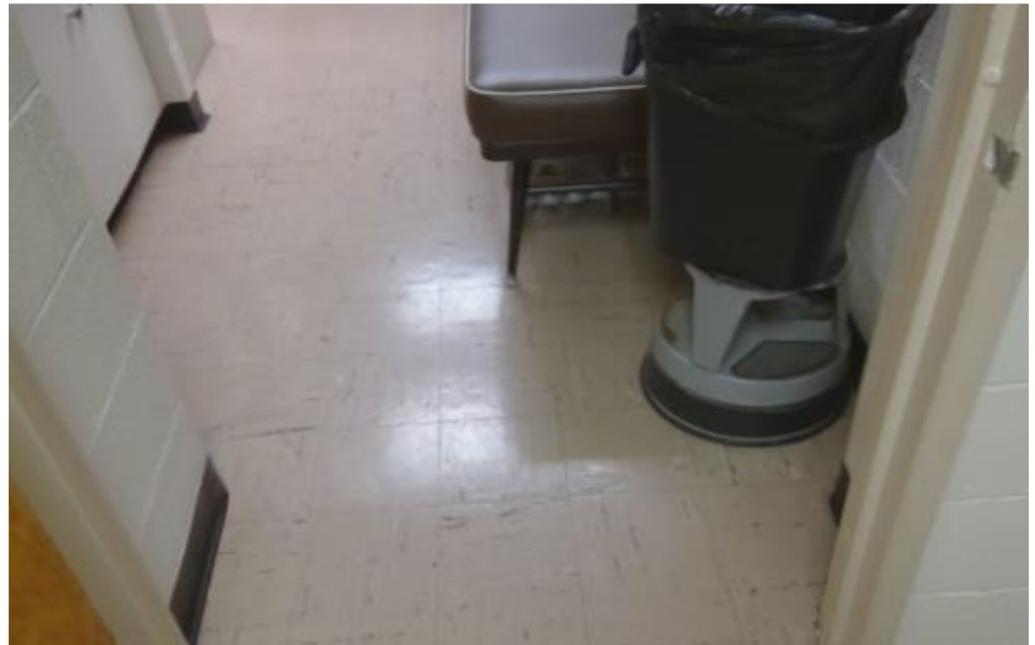
*Existing asbestos containing floor tile*

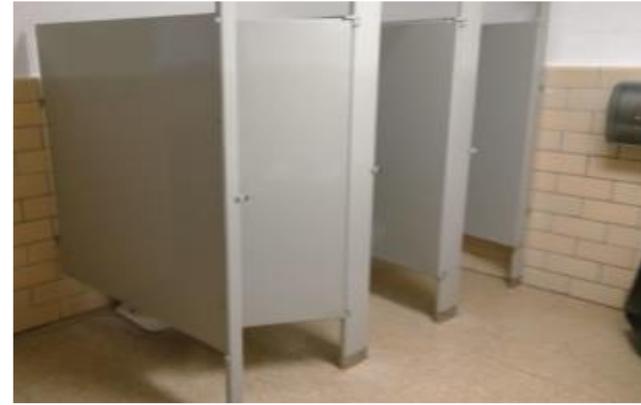
*Existing conditions*

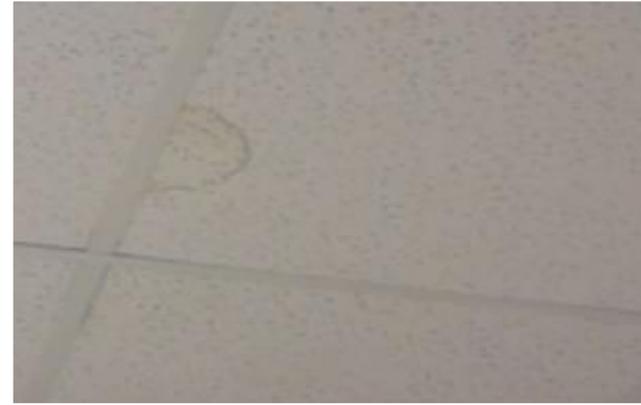
*Existing water damaged ceiling tile*

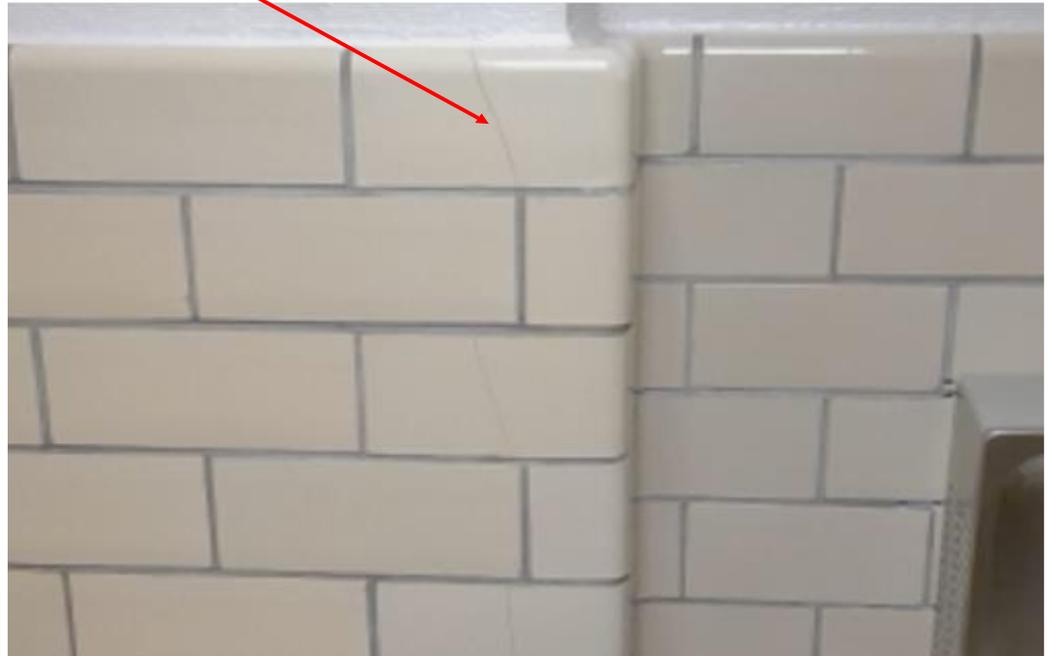
*Existing crack in wainscoting*

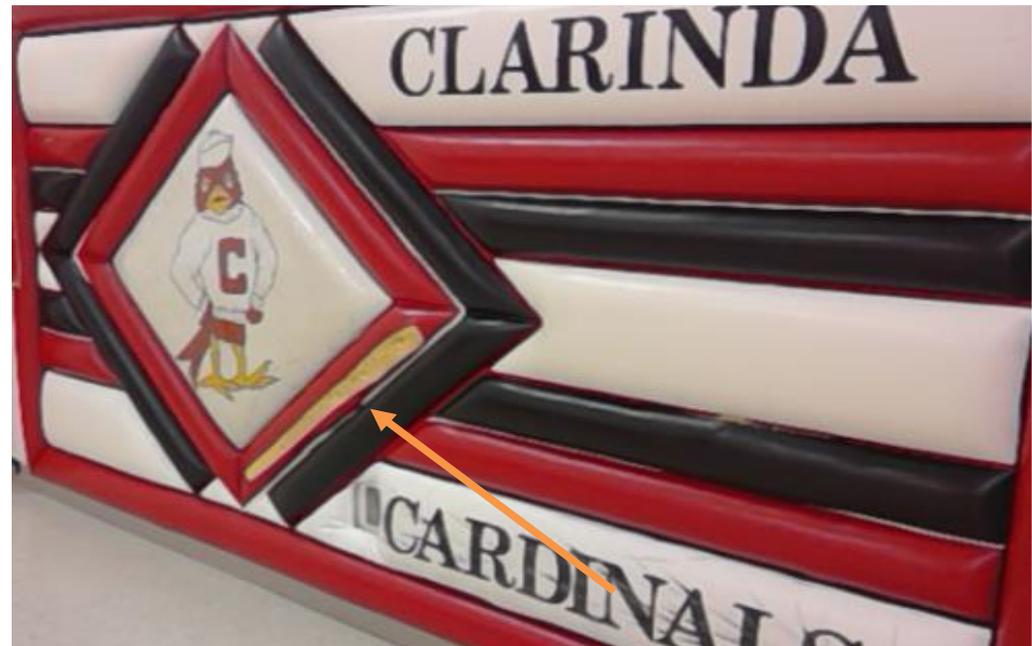
*Existing damaged gymnasium wall pads*

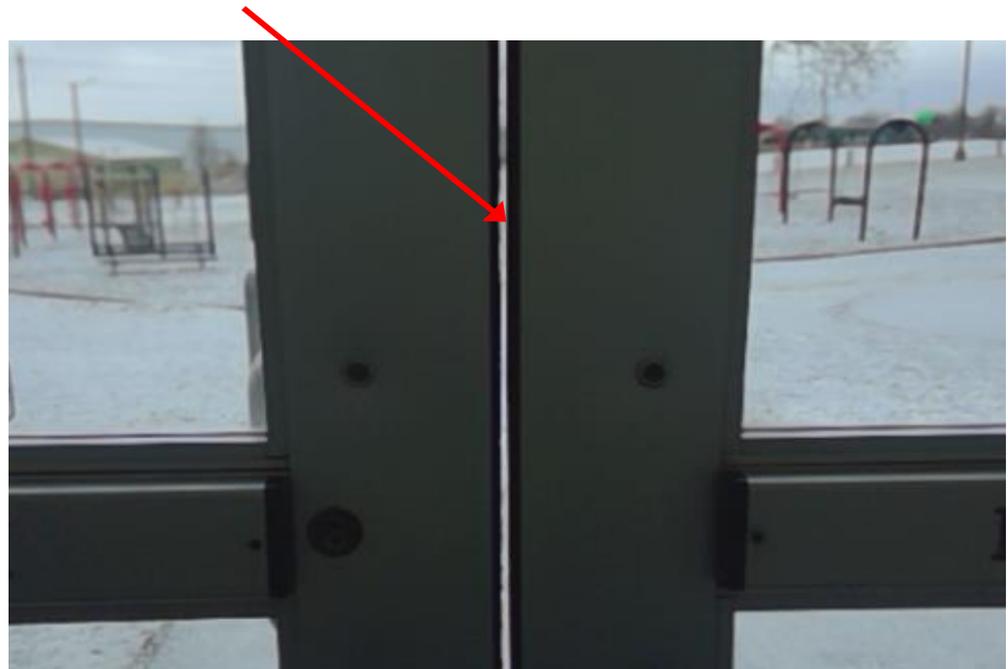
*Existing air gap at exterior doors*

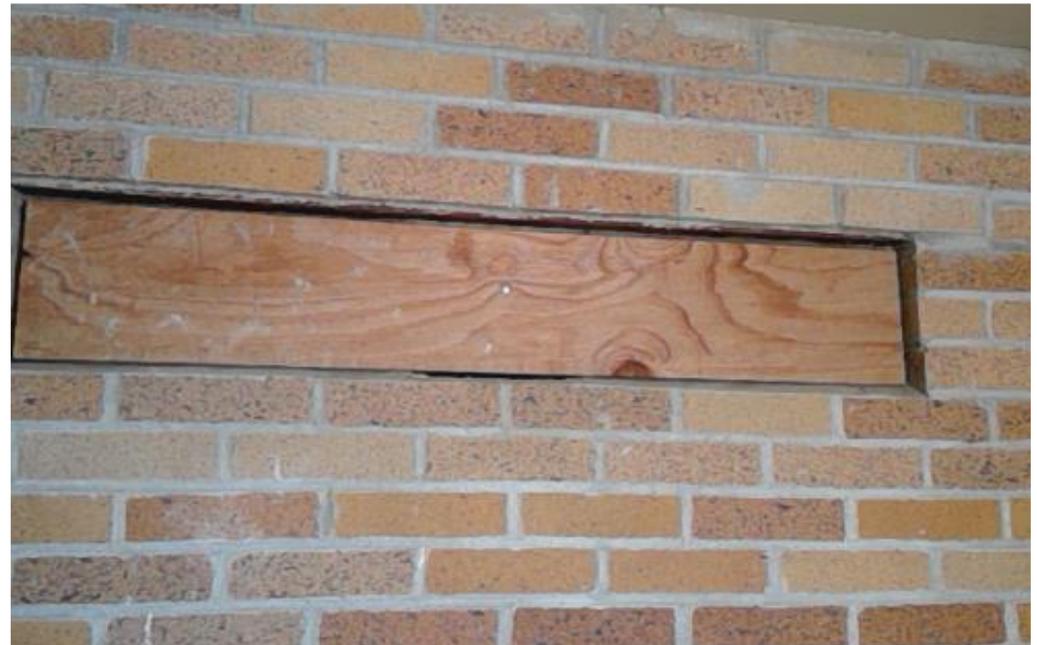
*Existing masonry opening*

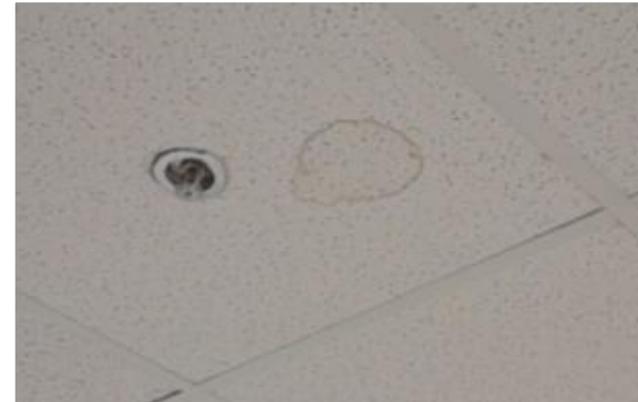
*Existing water damaged ceiling tile*

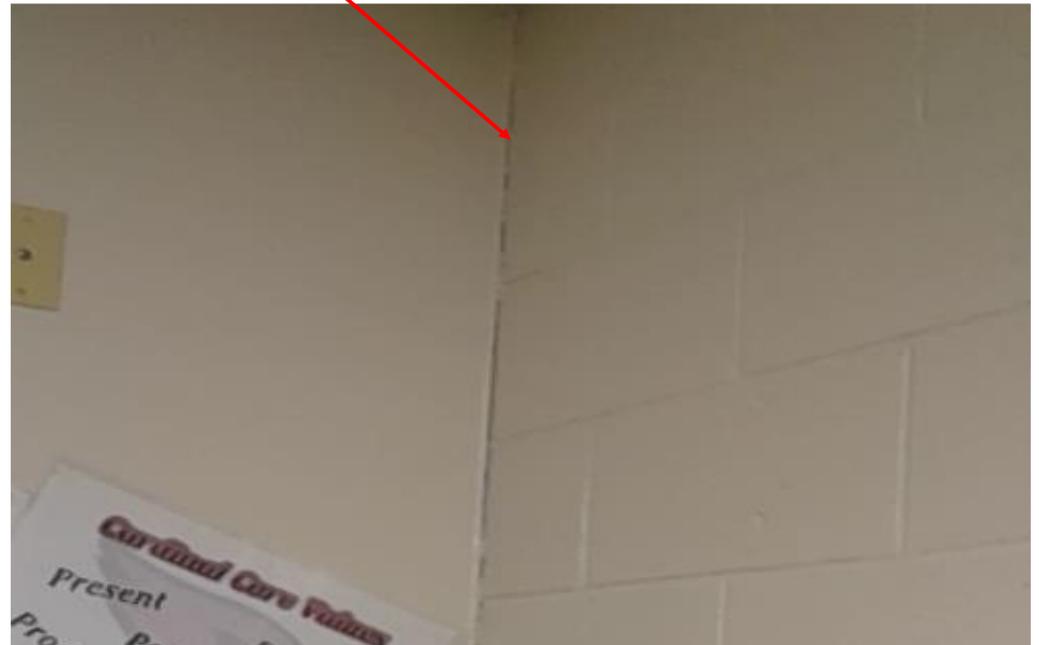
*Existing masonry caulk joint*

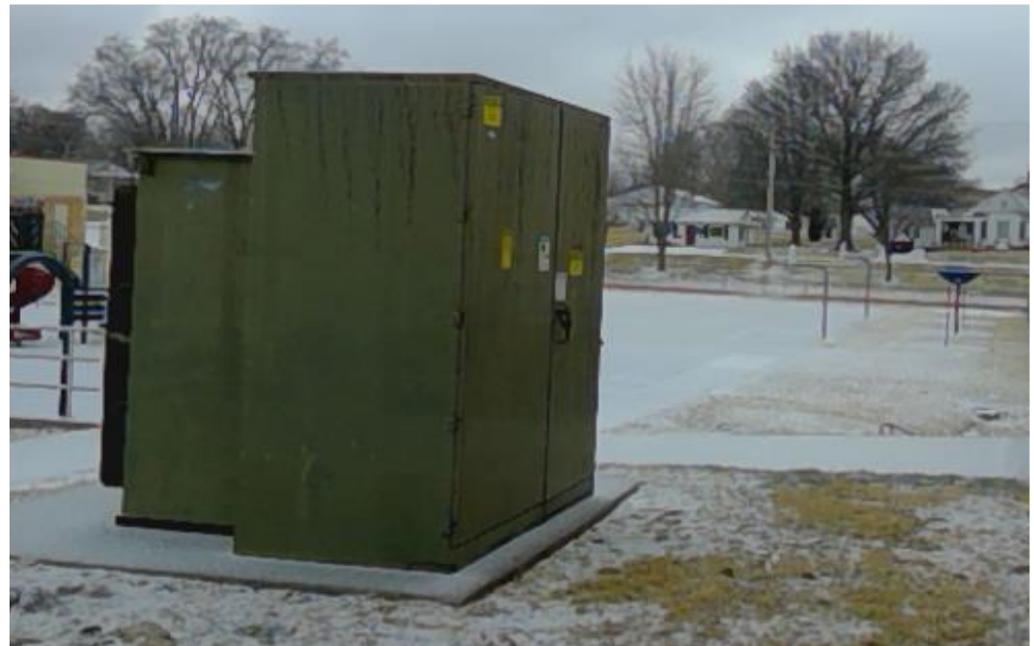
*Existing equipment*

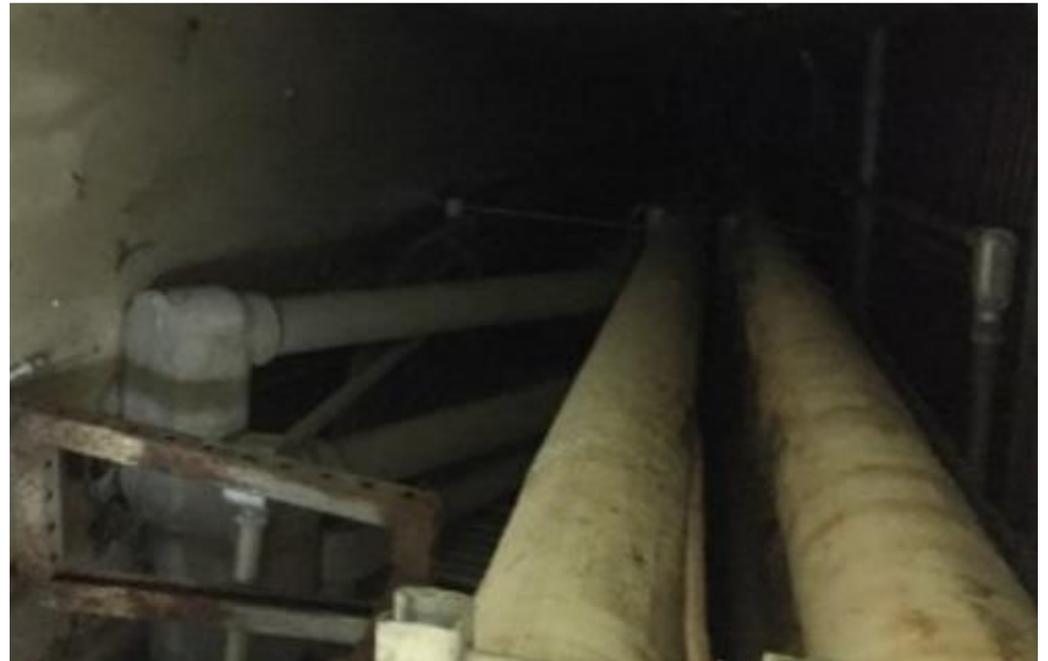
*Existing asbestos insulation*

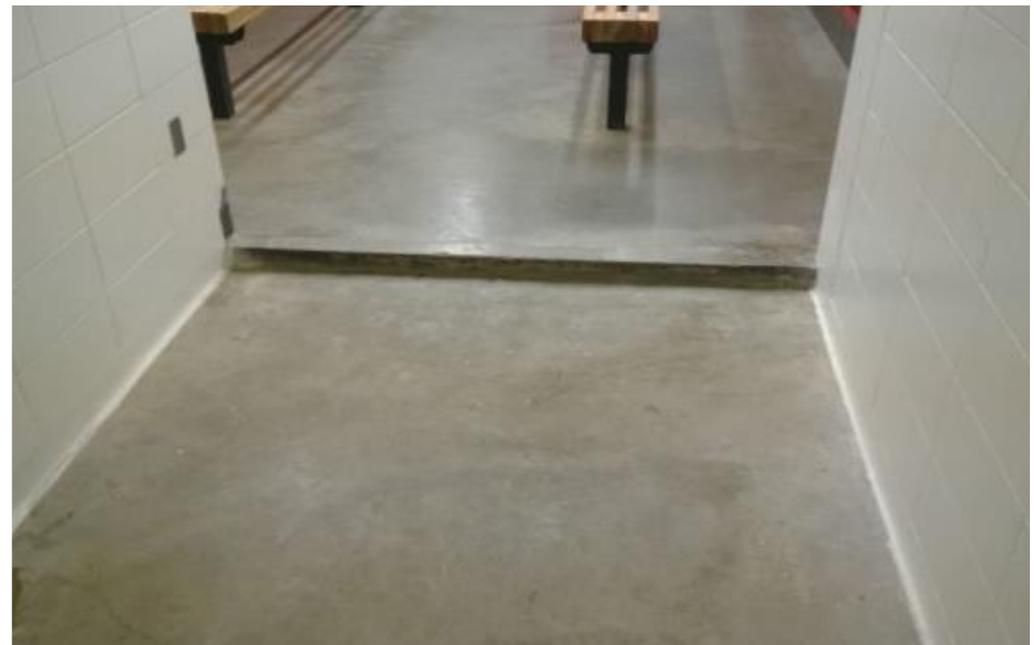
*Existing step down in floor*

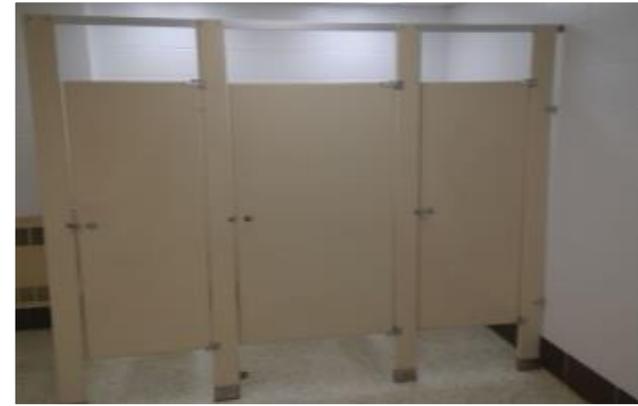
*Existing conditions*

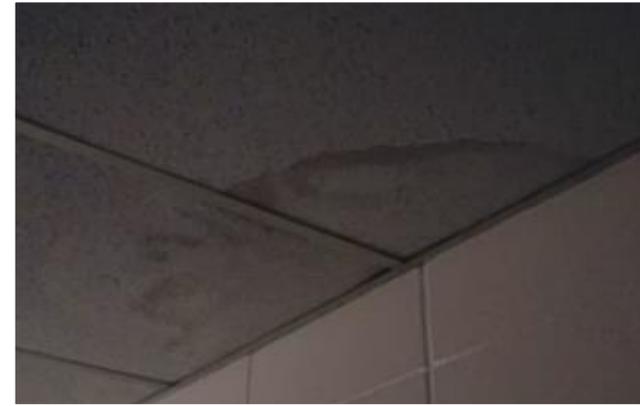
*Existing water damaged ceiling tile*

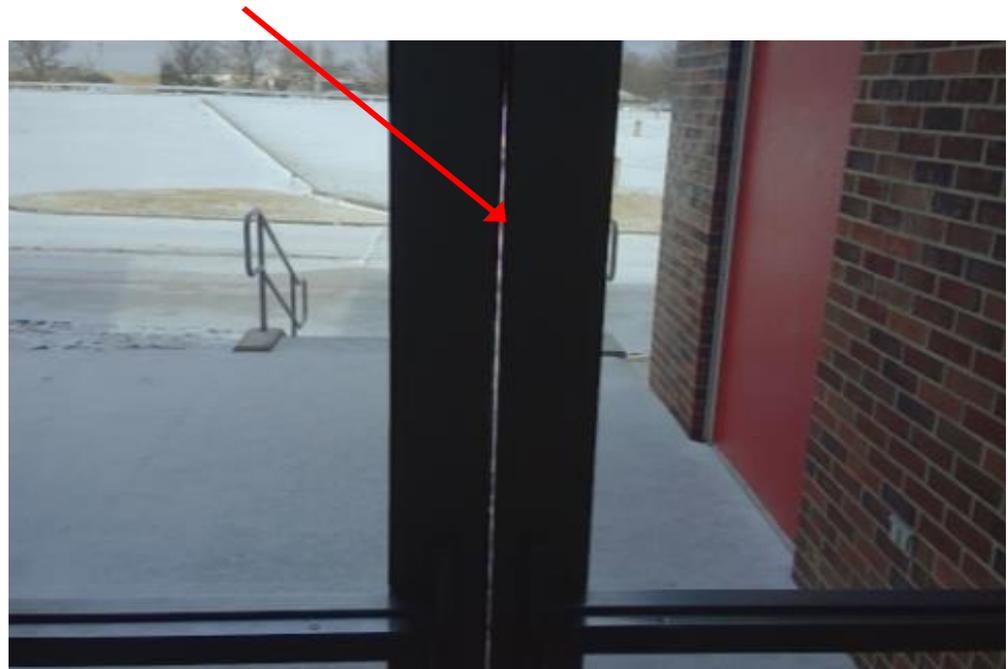
*Existing air gap at exterior doors*

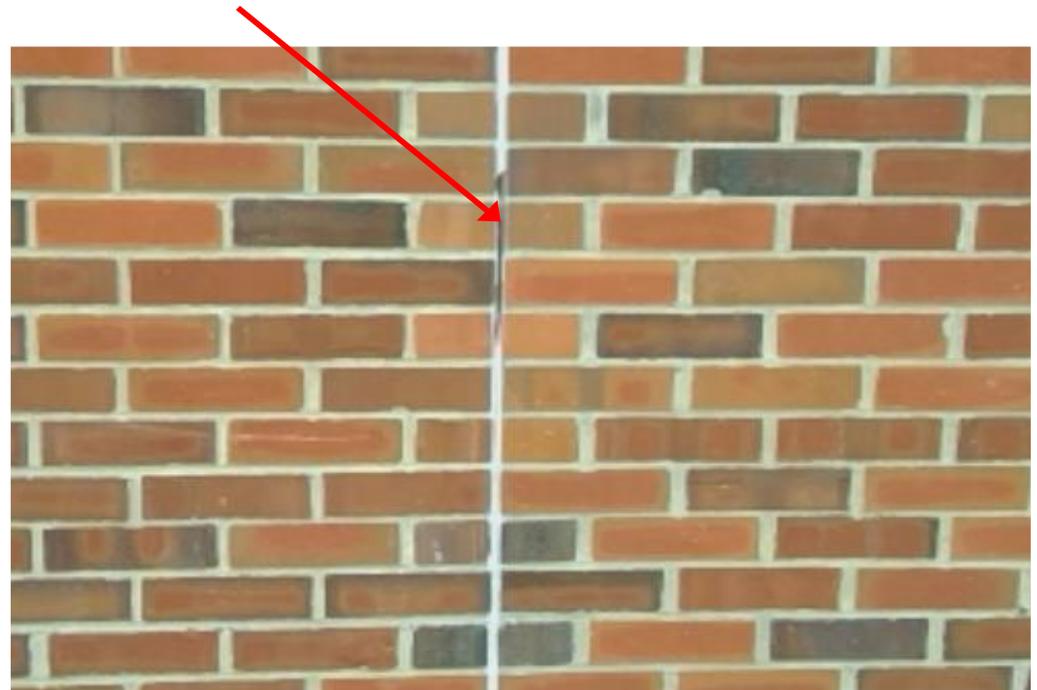
*Existing masonry requiring new joint sealant*

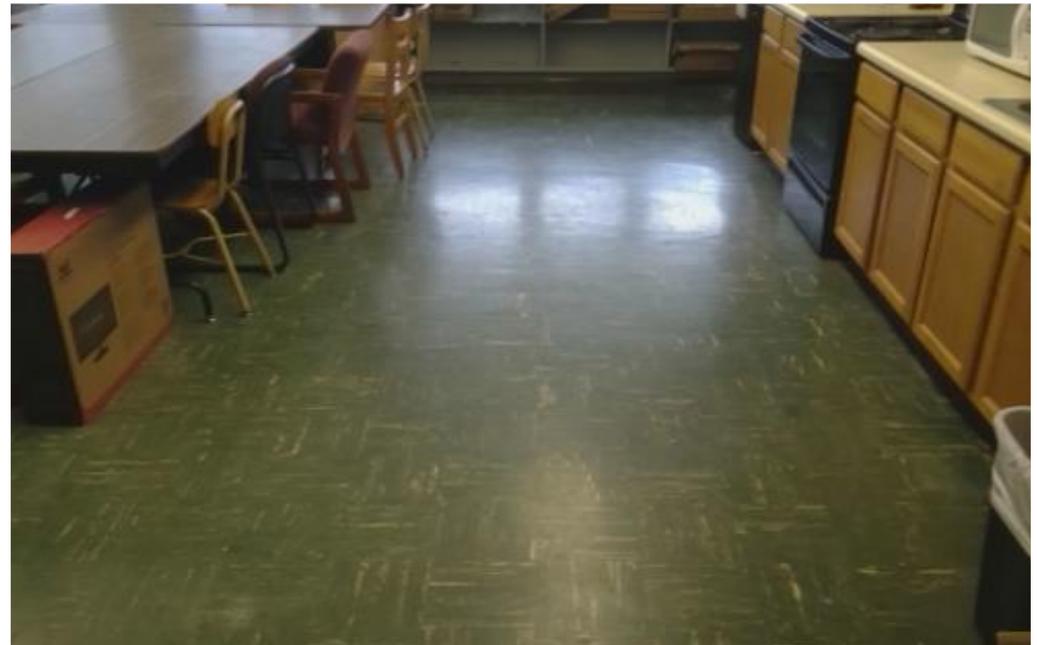
*Existing asbestos containing floor tile*

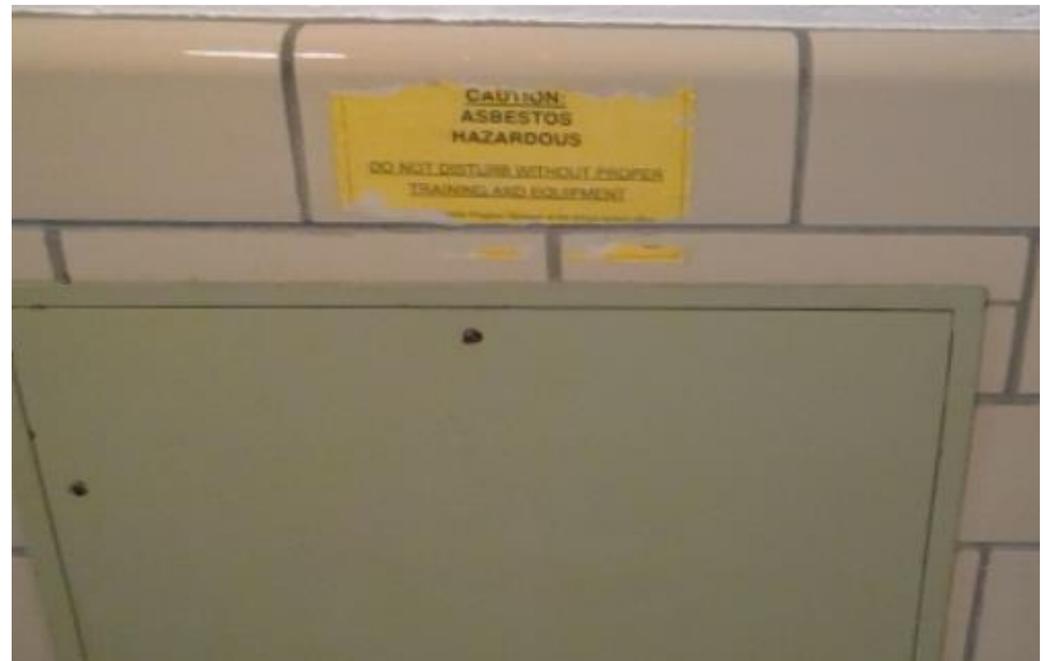
*Asbestos insulation warning label*

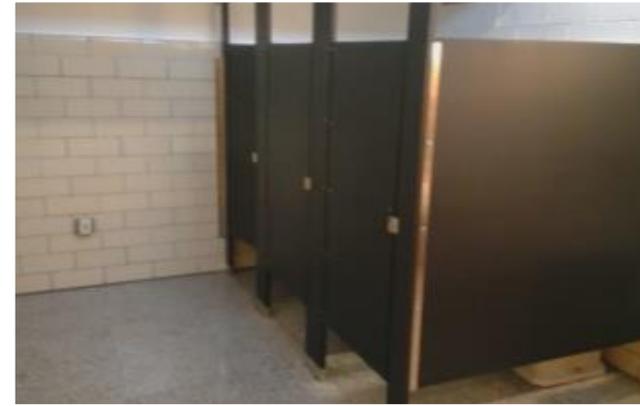
*Existing conditions*

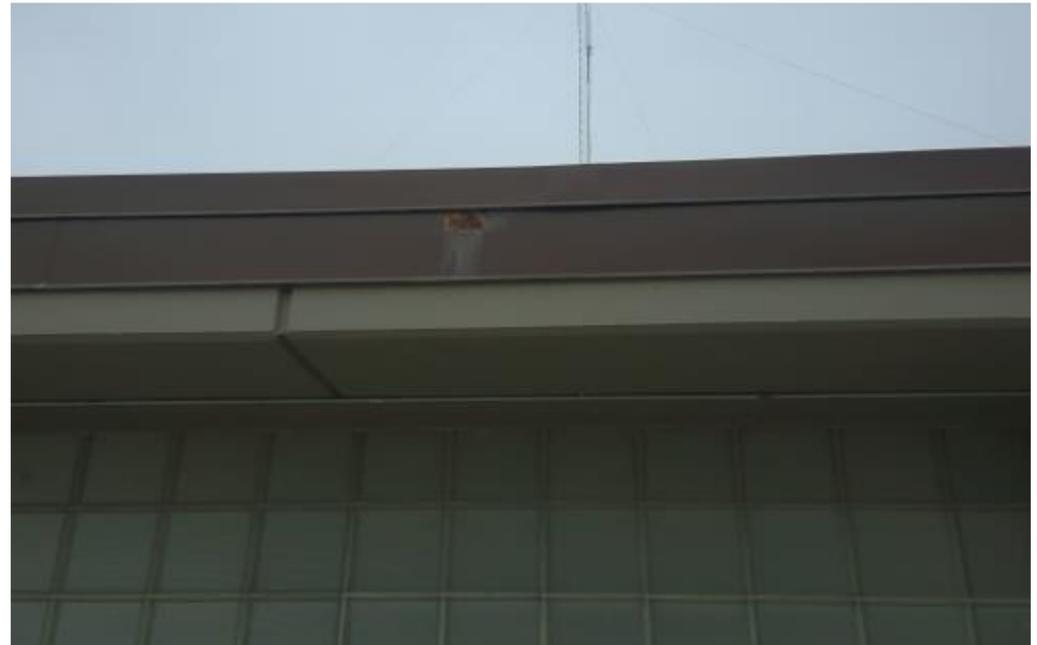
*Existing damaged fascia*

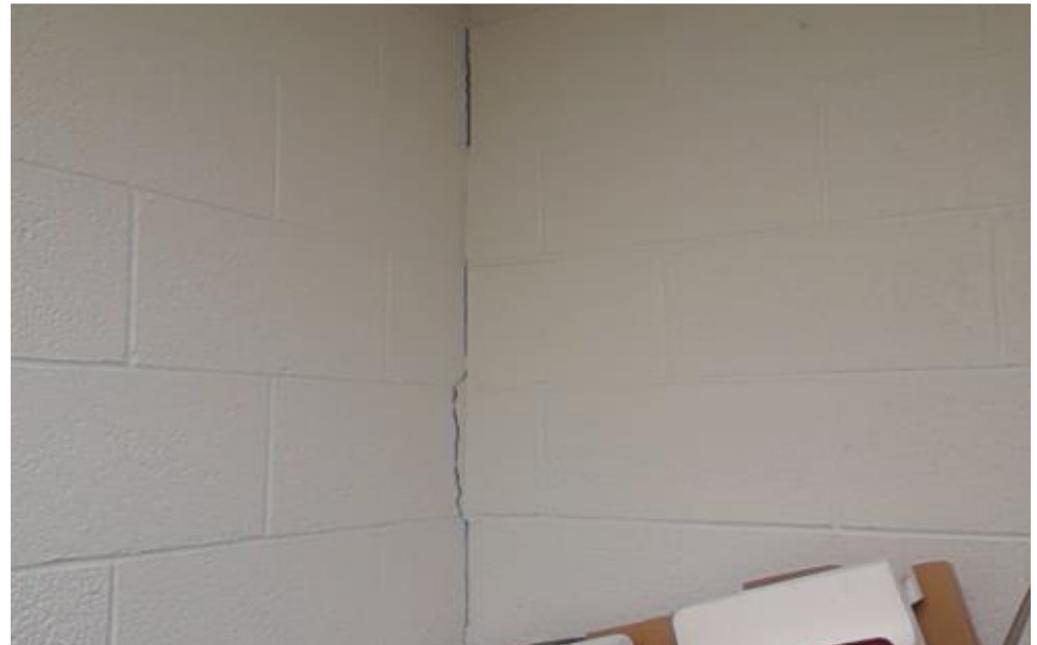
*Existing masonry caulk joint*

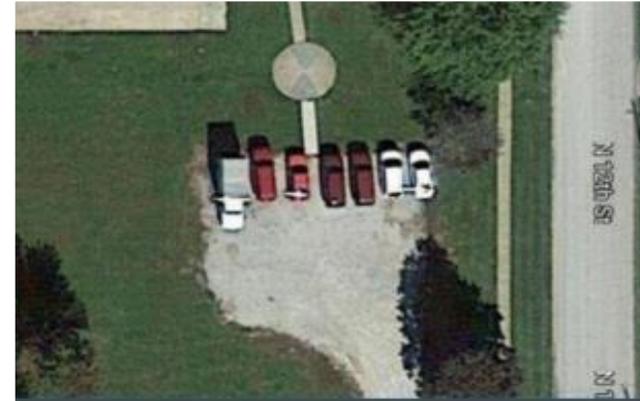
*Existing parking conditions*

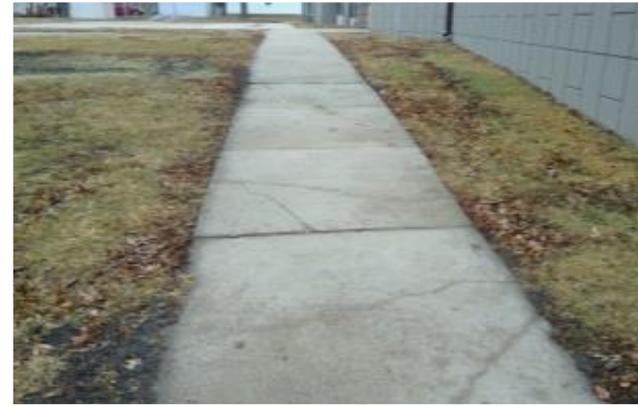
*Existing sidewalks needing repair*

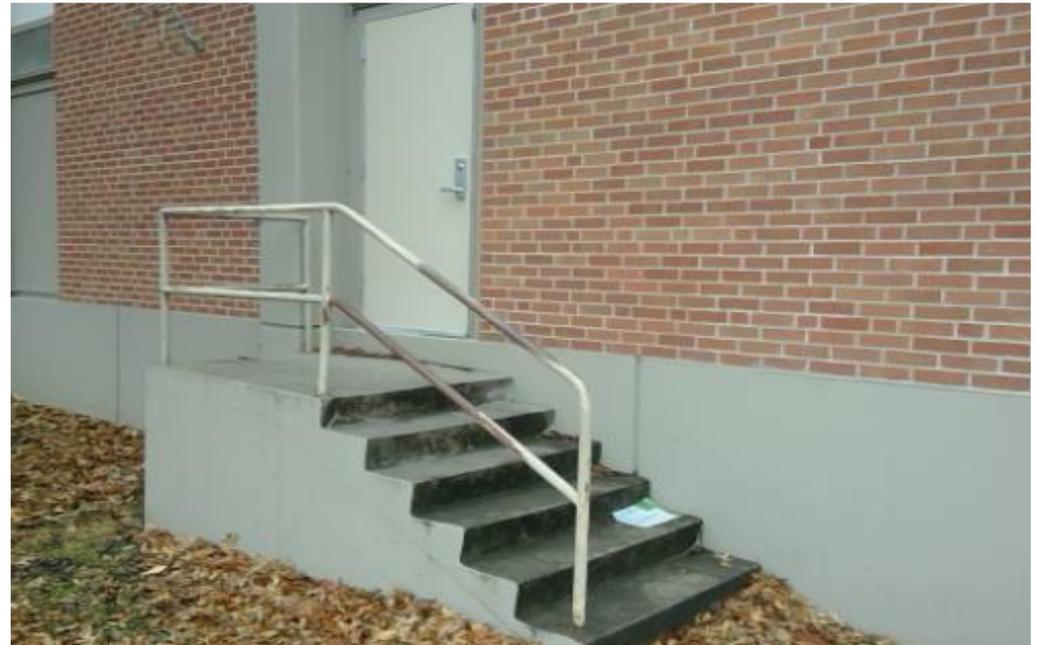
*Existing exterior stairs*

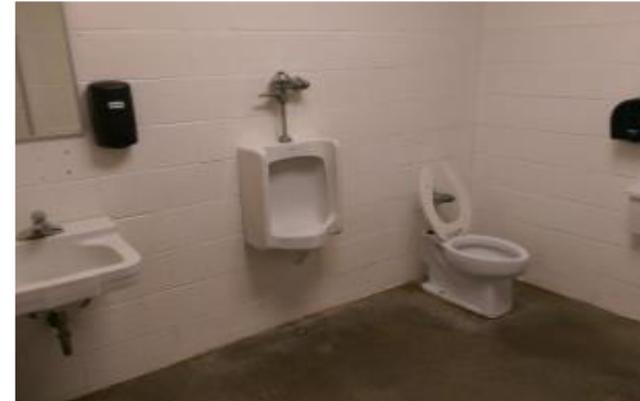
*Existing conditions*

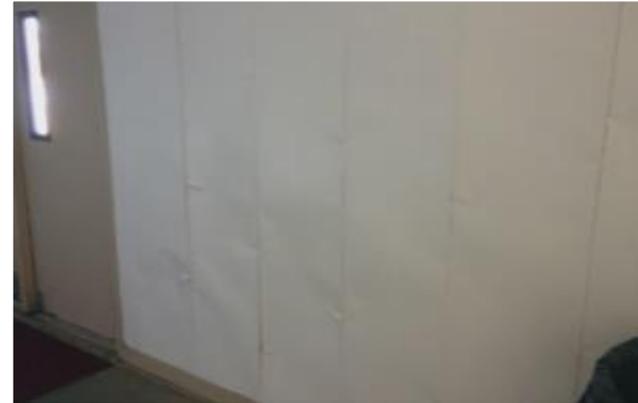
*Existing wall conditions*
