# CLARINDA COMMUNITY SCHOOL DISTRICT

FACILITY CONDITION ASSESSMENT  
February 19th, 2018

## EXECUTIVE SUMMARY

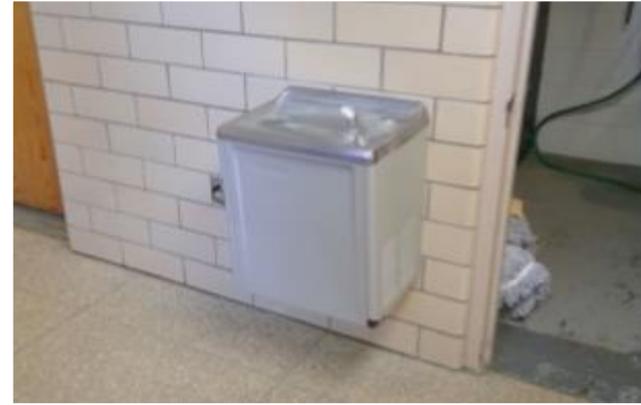
*Existing water cooler*

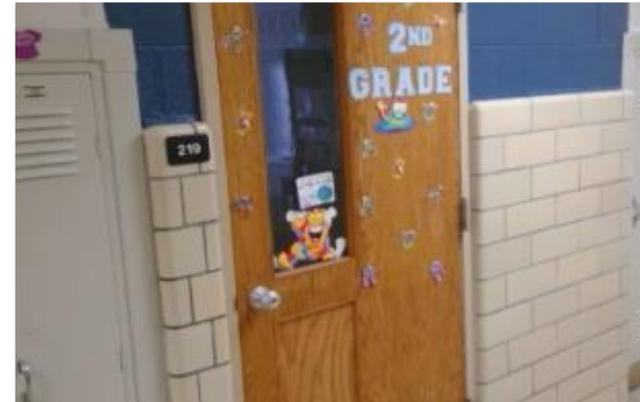
*Existing non-compliant door and hardware*

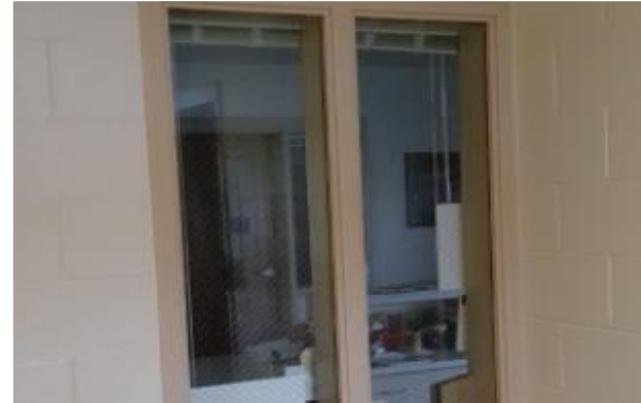
*Existing wired glazing*

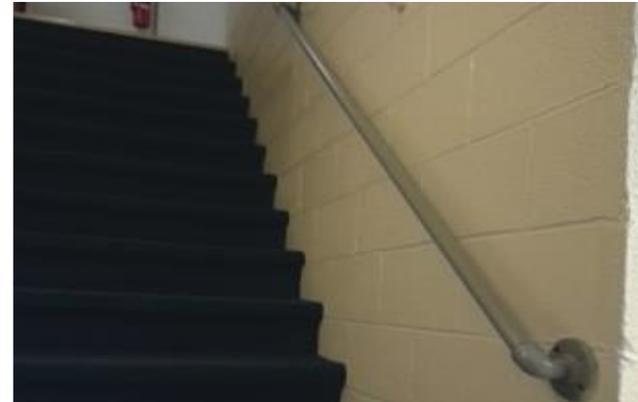
*Existing non-compliant stair railings*

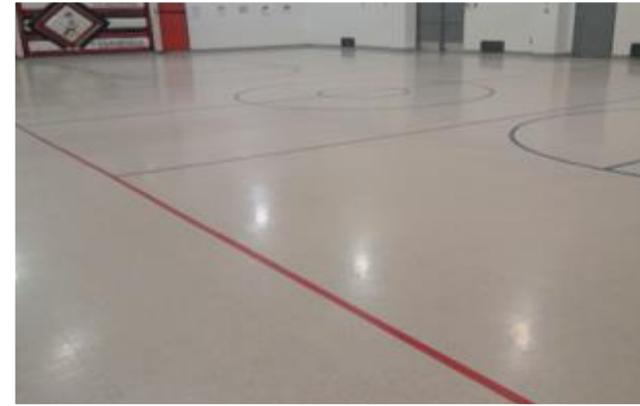
*Existing VCT gymnasium flooring*

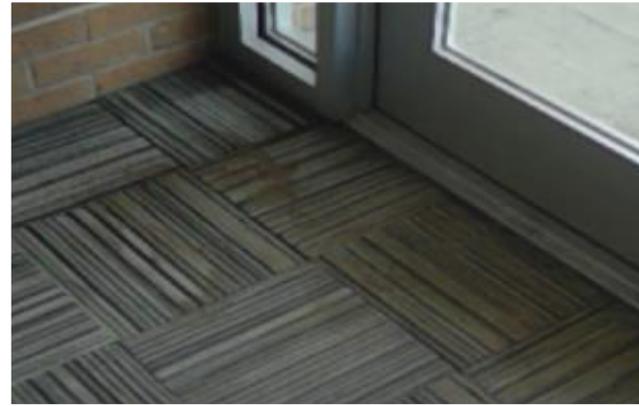
*Existing walk off carpet*

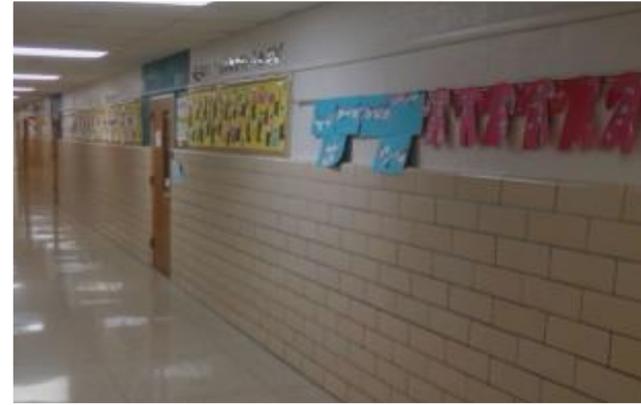
*Existing tile wainscoting*

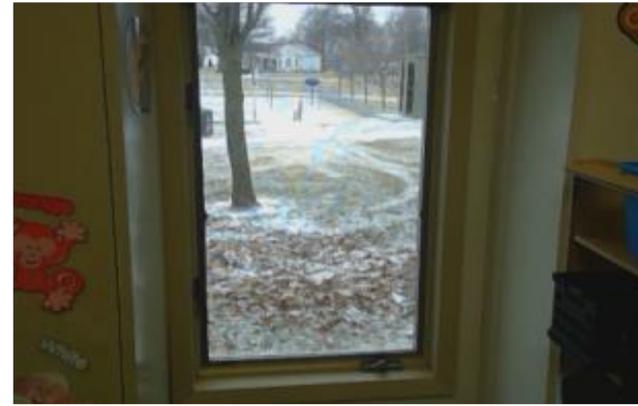
*Existing exterior window*

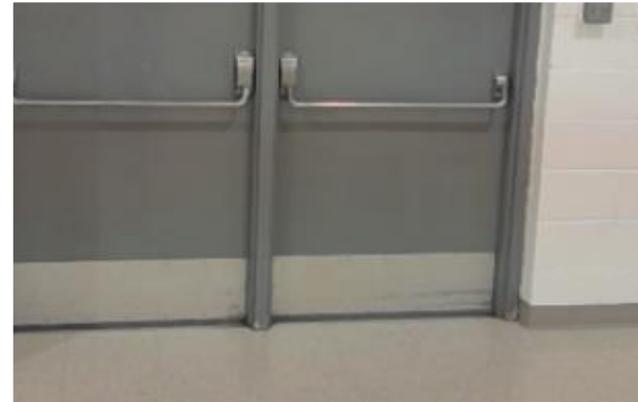
*Existing exterior door*

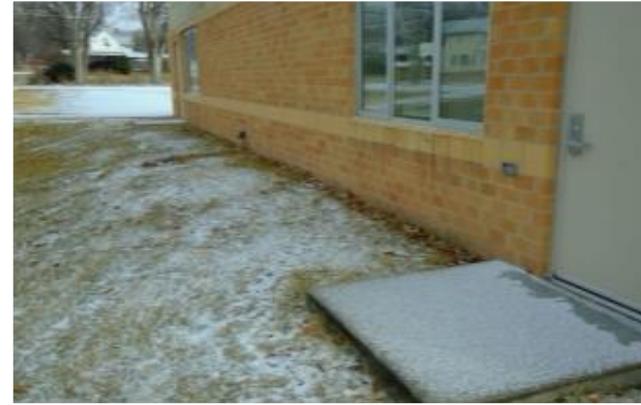
*Existing exit doors without path of egress*

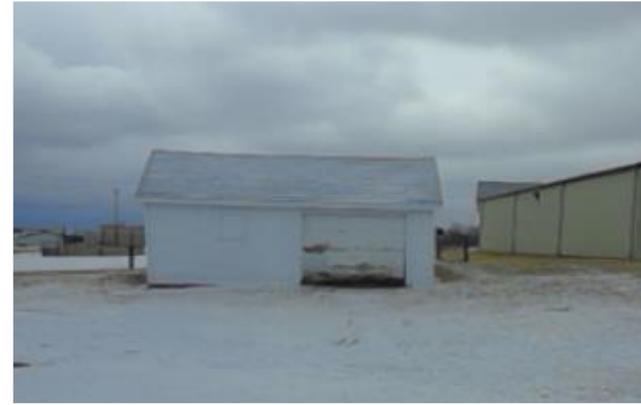
*Existing overhead door at storage shed*

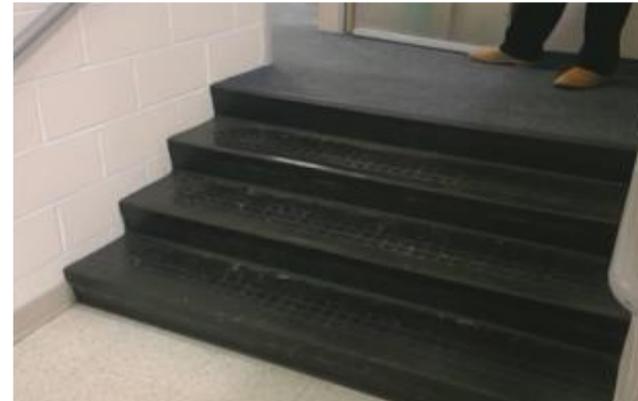
*Existing stairs to stage*

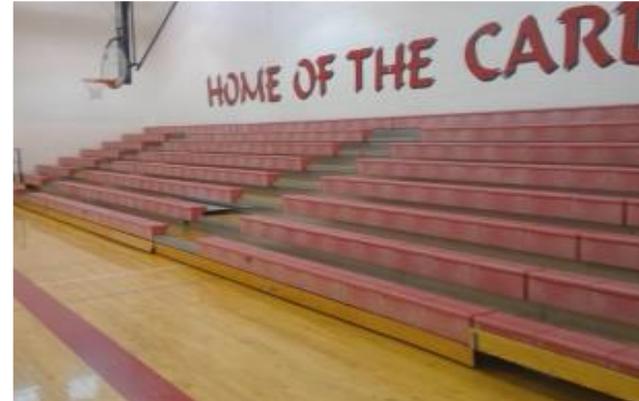
*Existing bleachers*

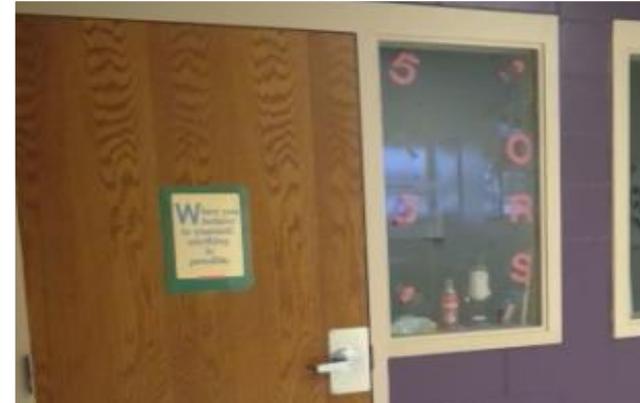
*Existing non-compliant glazing*

Replace the existing non-compliant glazing with new safety rated or tempered glazing.

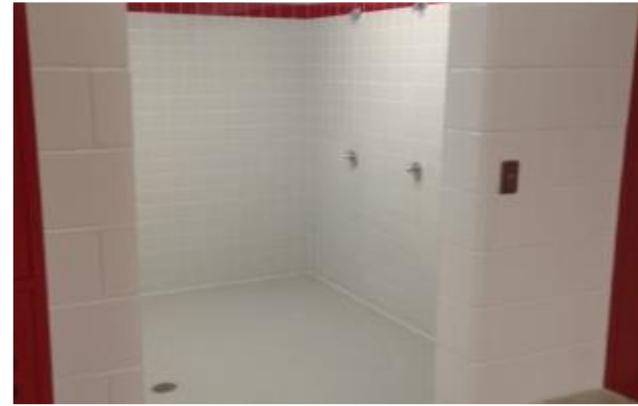
*Existing communal drain in shower*

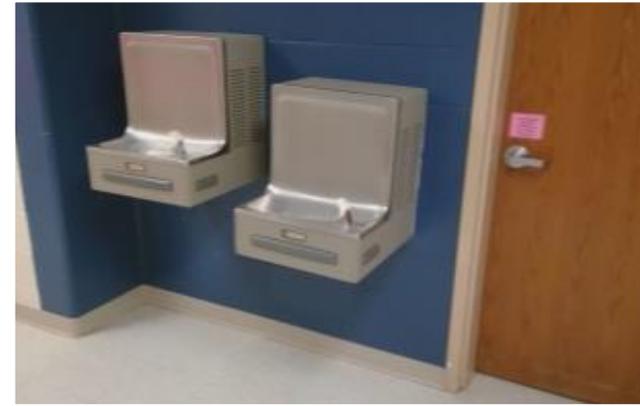
*Existing water cooler*

Replace existing water coolers with bottle fill style water coolers.

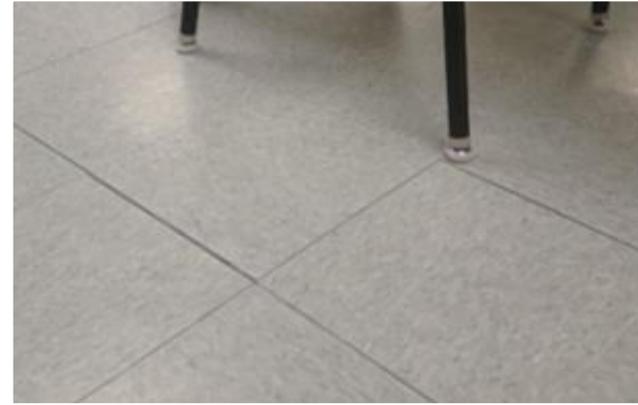
*Existing flooring*

Remove and replace existing VCT flooring.

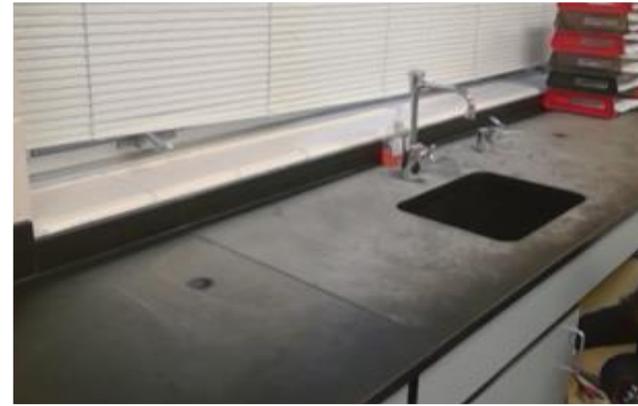
*Existing countertop*

Remove and replace existing countertops with new acid-proof countertops.

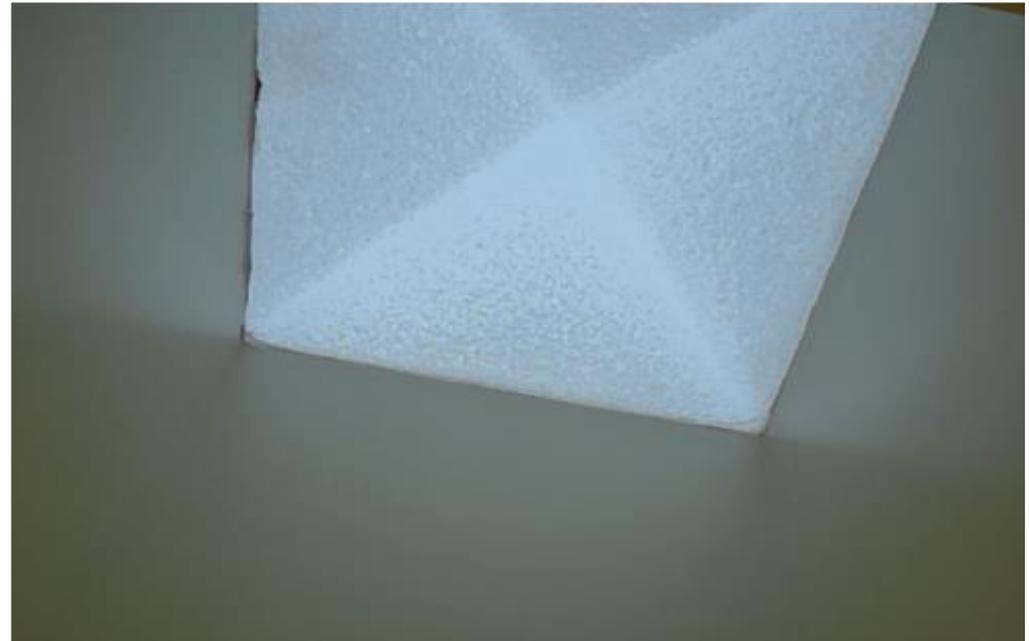
Existing wall finishes located at skylights in corridors are showing signs of water damage.

*Existing wall finish at skylights*

Repair damaged finishes, re-caulk around skylights.

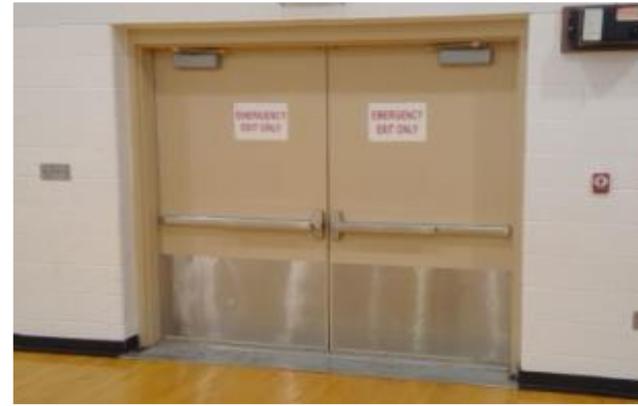
*Existing exterior door*

Replace existing exterior doors with new.

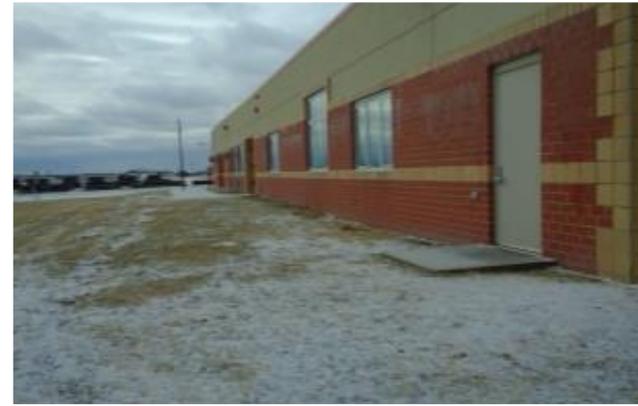
*Existing exit doors without path of egress*

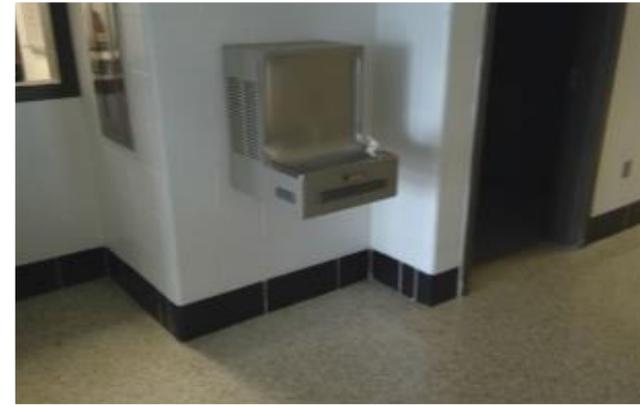
*Existing water cooler*

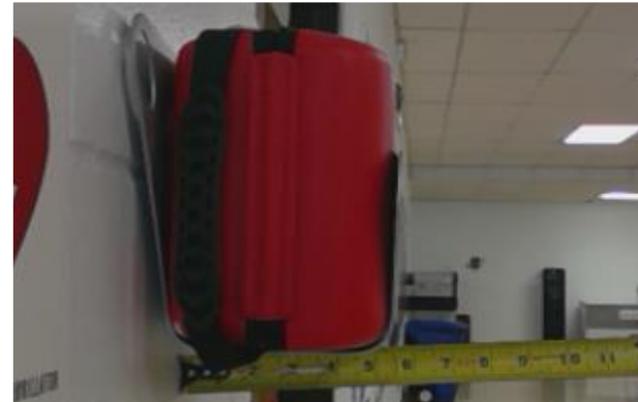
*Existing defibrillator*

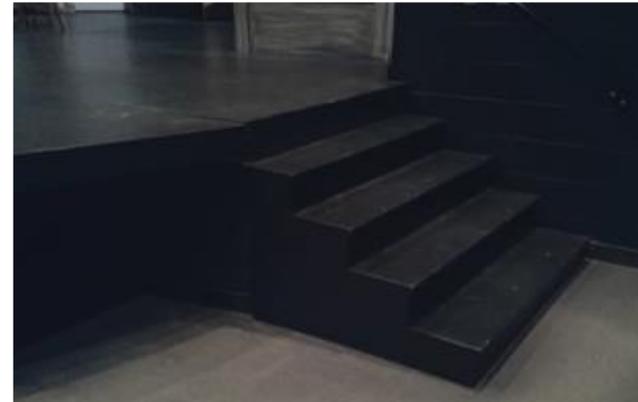
*Existing stage access*

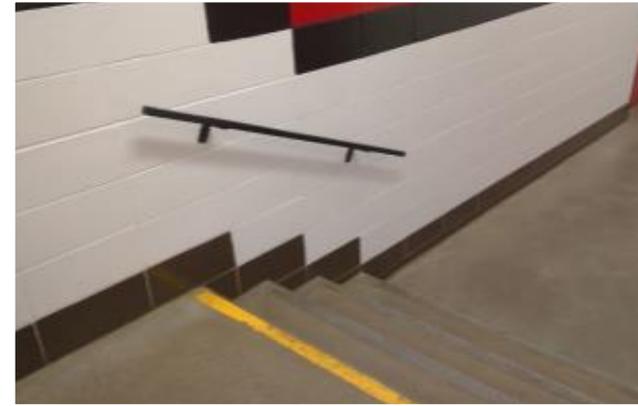
*Existing non-accessible floor*

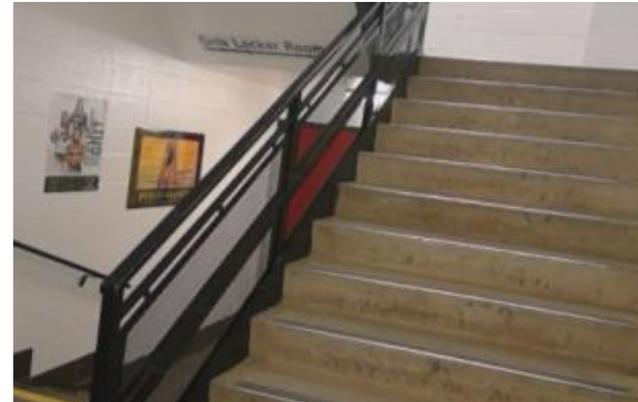
*Existing non-compliant stair railings*

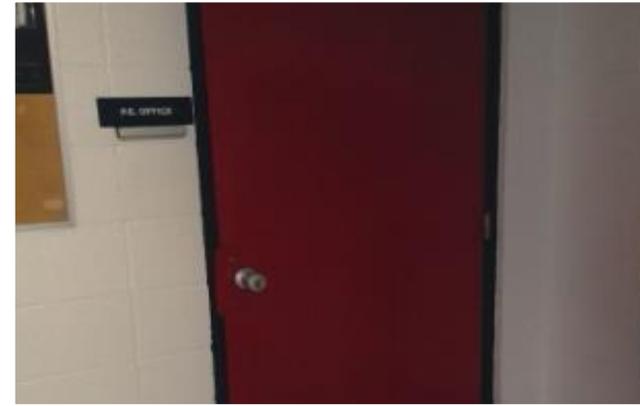
*Existing non-compliant door hardware*

Replace existing hardware with new code compliant hardware.

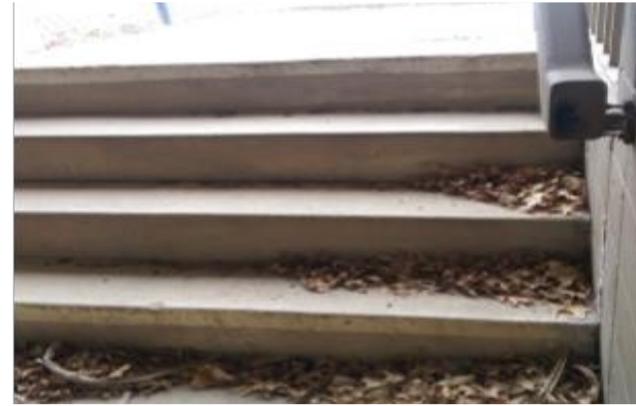
*Existing non-accessible entryway*

Replace exterior egress stairs with new ADA compliant ramp.

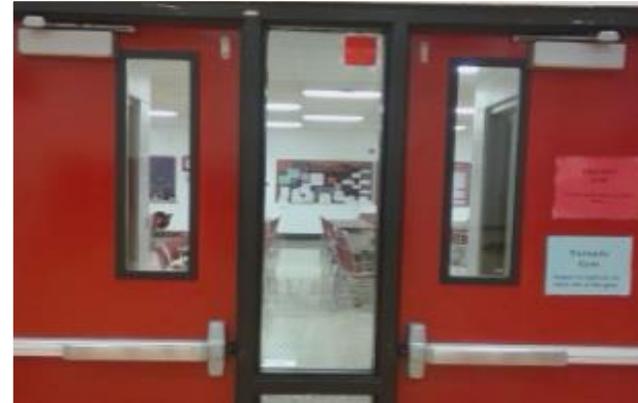
*Existing non-rated corridor door*

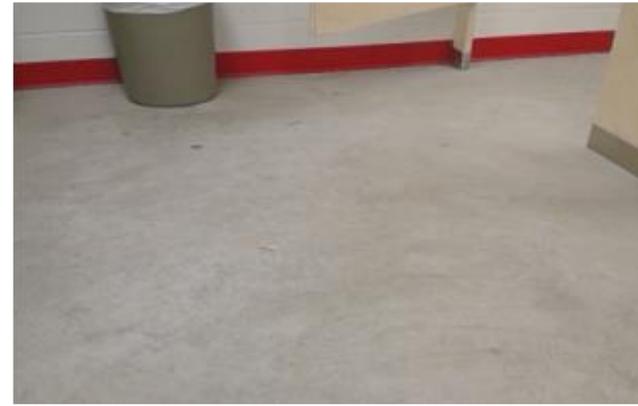
*Existing sealed concrete floor*

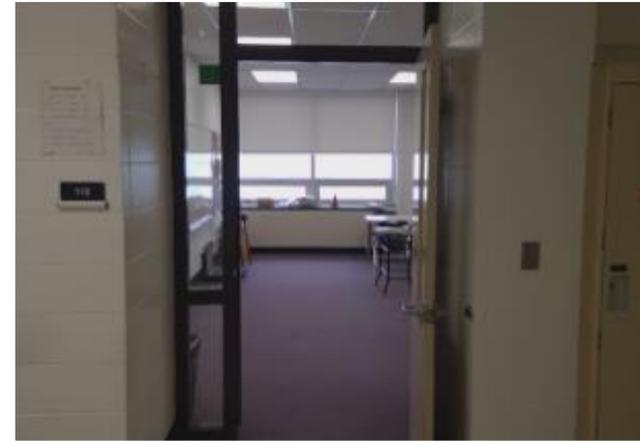
*Example of existing door/frame*

Remove existing door and frame and replace with new.

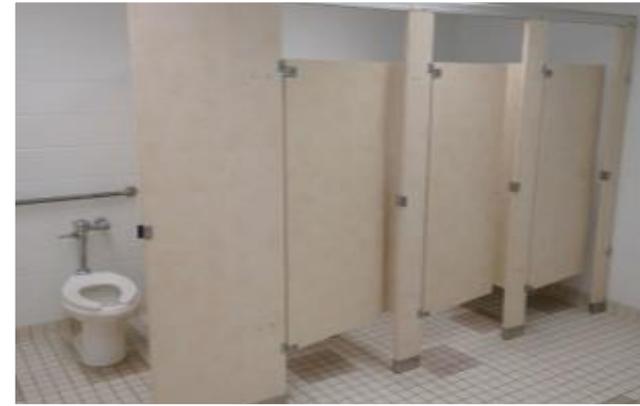
Existing restroom finishes are worn, dated, and have reached end of useful life.

*Existing restroom finishes*

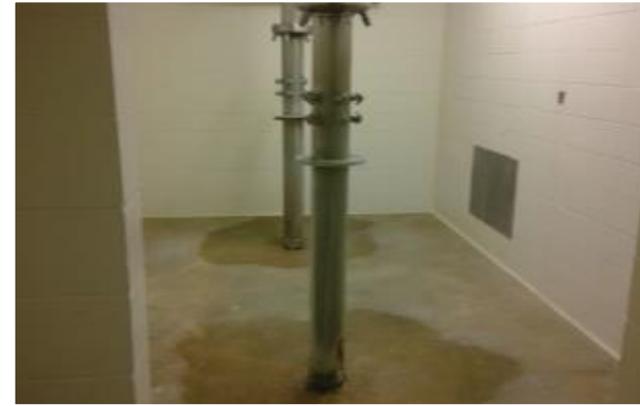
Existing shower finishes are worn, dated, and have reached end of useful life.

*Existing shower finishes*

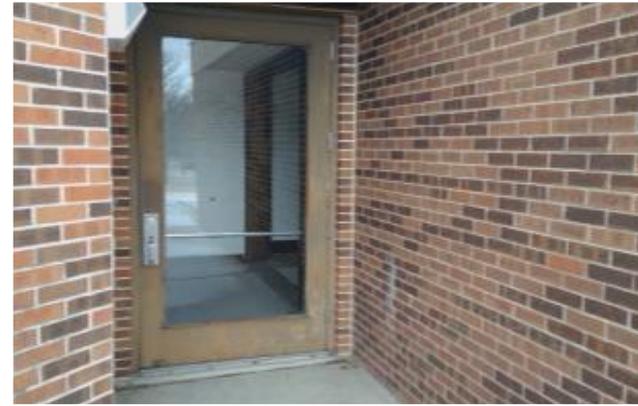
*Existing exterior door*

Replace the existing with new energy-efficient exterior doors.

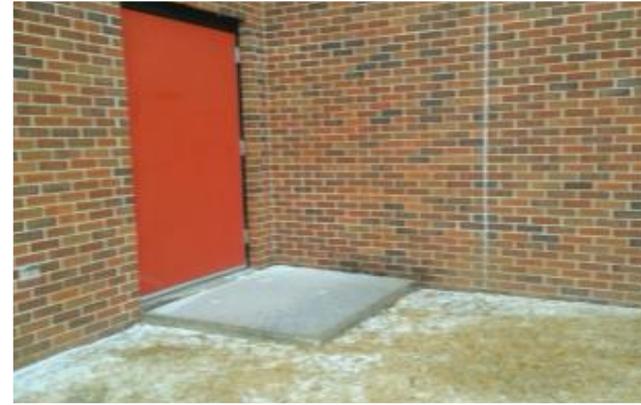
*Existing exit doors without path of egress*

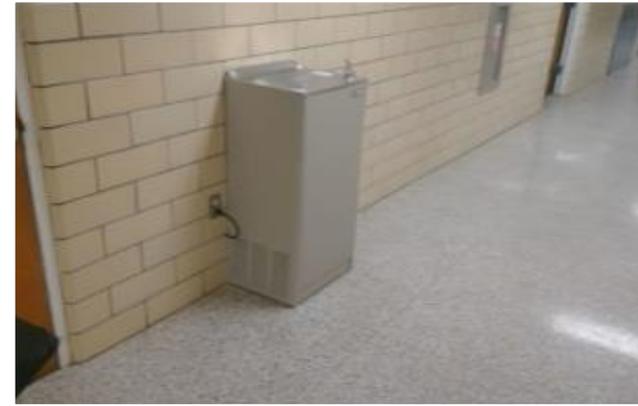
*Existing water cooler*

Replace existing with new water coolers that are compliant with the Americans with Disabilities Act (ADA).

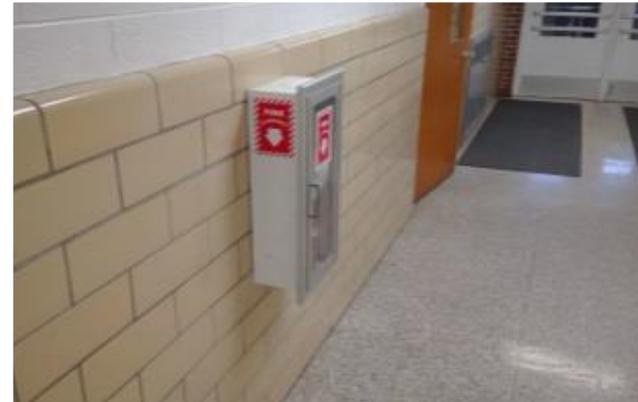
*Existing fire extinguisher cabinet*

Remove existing fire extinguisher cabinets and replace with a recessed or semi-recessed ADA compliant fire extinguisher cabinet.

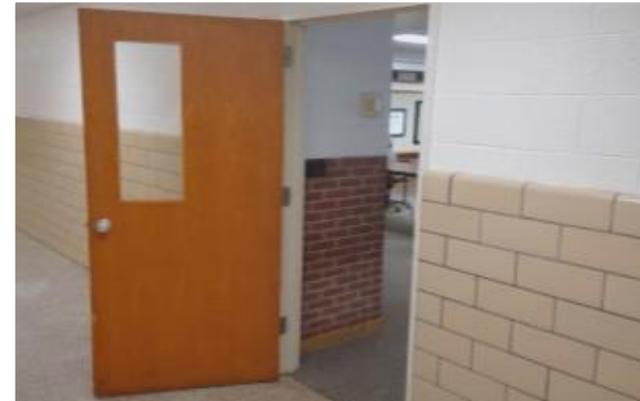
*Existing non-compliant door*

Replace existing doors and hardware with new.

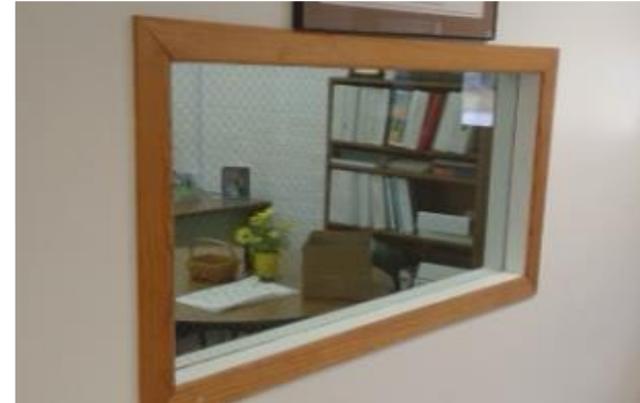
*Existing non-compliant glazing*

Replace the existing non-compliant glazing with new safety rated or tempered glazing.

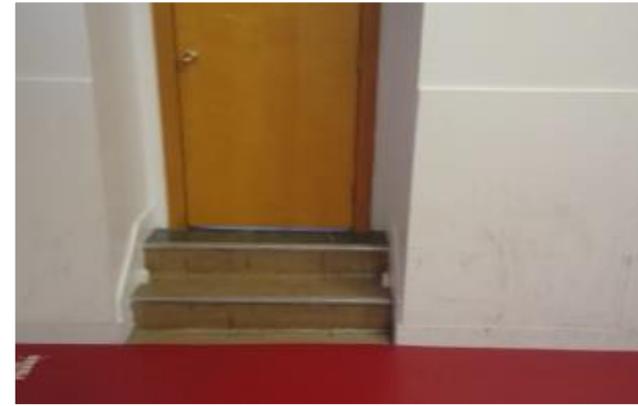
*Existing non-accessible floor*

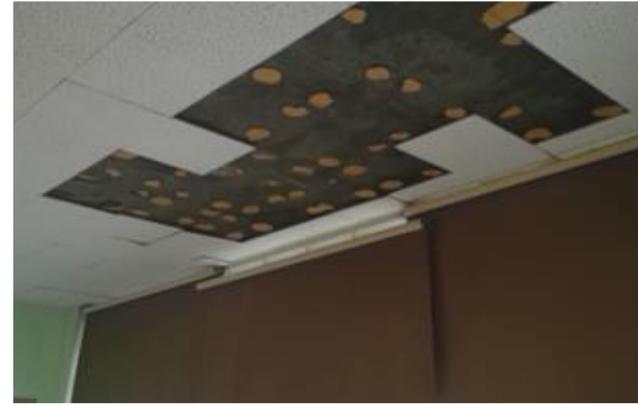
*Existing ceiling*

Remove and replace with a new acoustical ceiling system. Acoustical ceilings cost are determined by tile size, thickness and finish desired.

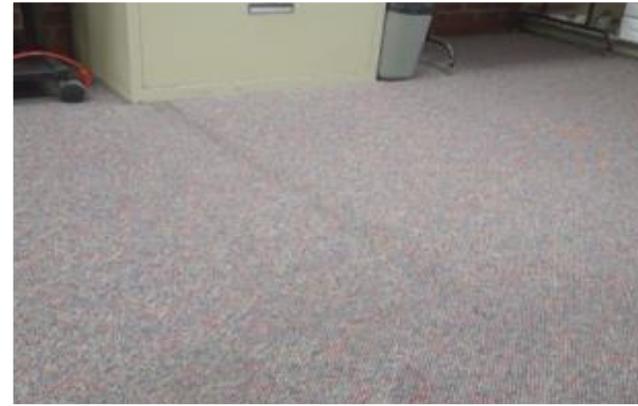
*Existing flooring*

Removed and replace existing flooring. Flooring costs vary based on product type, thickness, and finish desired.

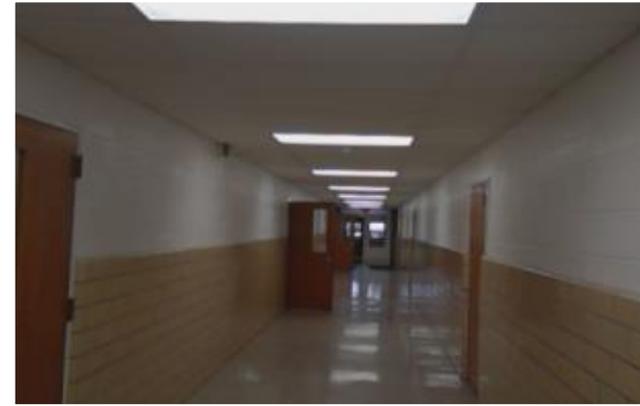
*Existing wall finish*

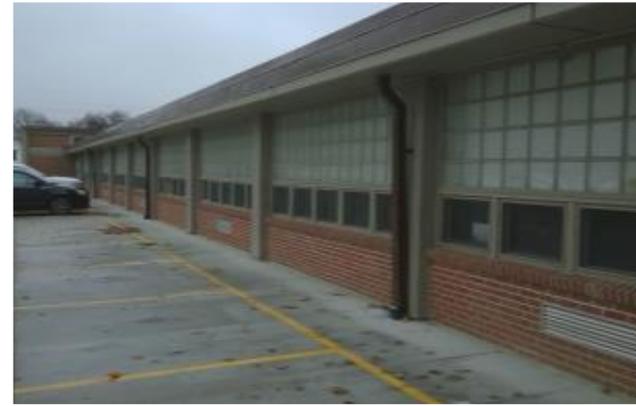
*Existing exterior windows*

Replace the existing with new energy-efficient exterior doors and windows.

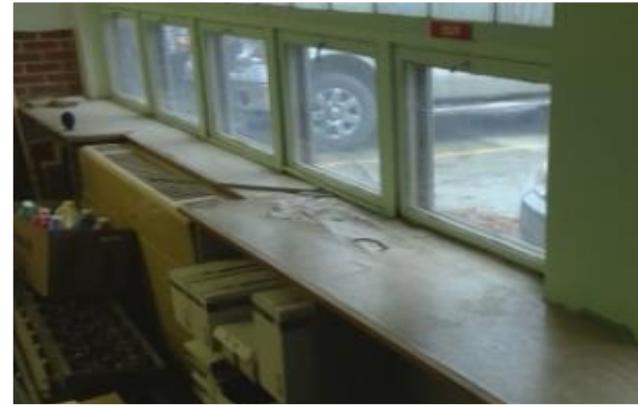
*Existing casework*

Remove and replace existing casework with new.

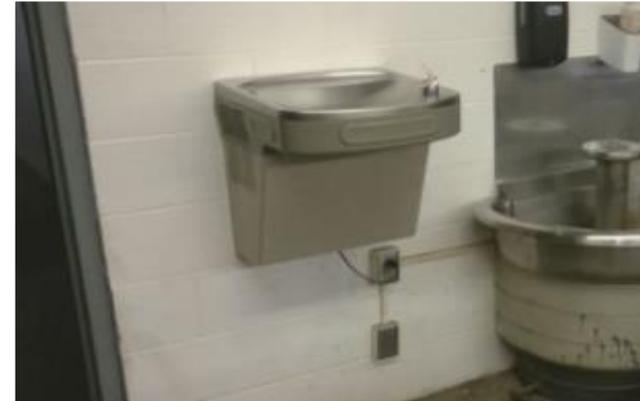
*Existing water cooler*

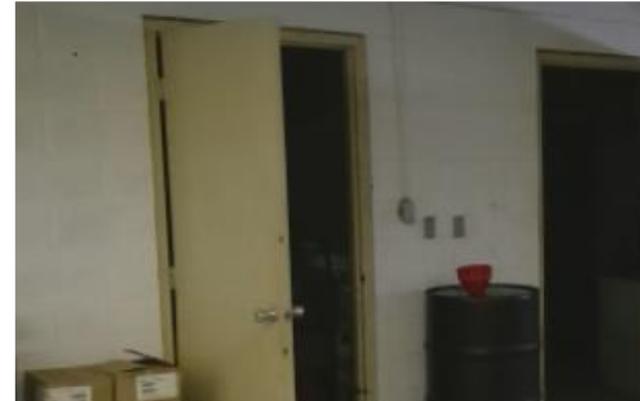
*Existing door and hardware*

Replace existing doors and hardware with new.

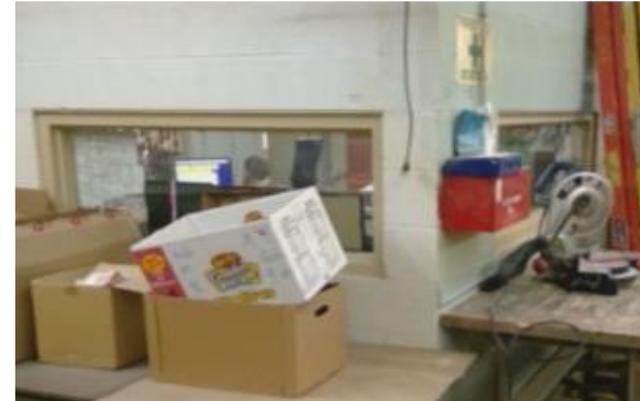
Existing glazing contains wired glazing and is no longer compliant with current building codes.

*Existing non-compliant glazing*

Replace the existing non-compliant glazing with new safety rated or tempered glazing.

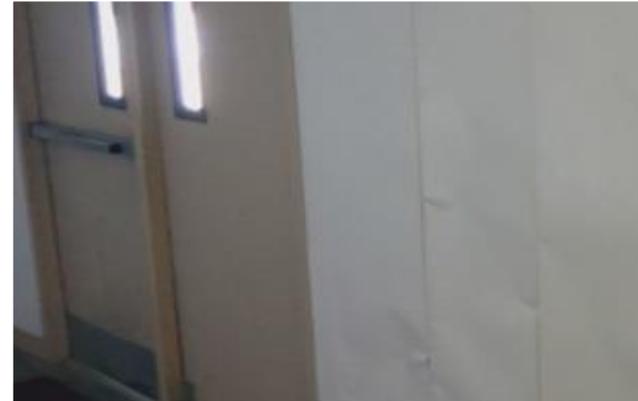
*Existing exterior door*

Replace existing exterior doors with new.

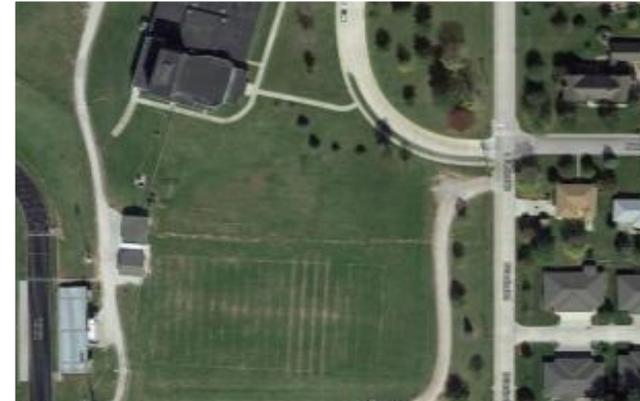
*Area in need of additional parking*

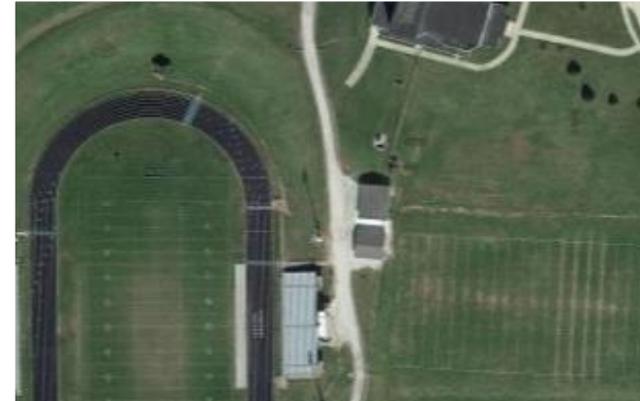
*Existing athletic field*

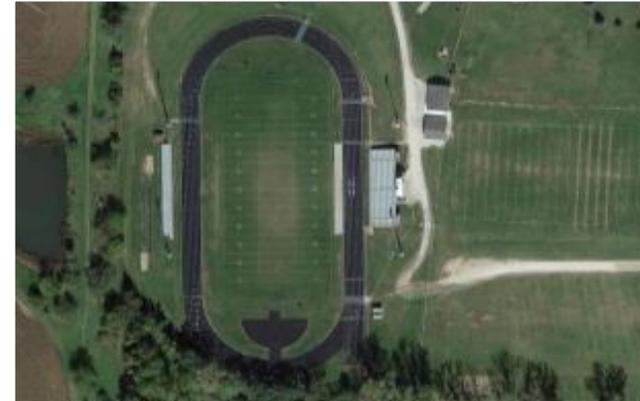
*Existing athletic field*

Replace the existing track and asphalt substrate with new, install new asphalt and athletic surface to "D" areas at each of the end zones.

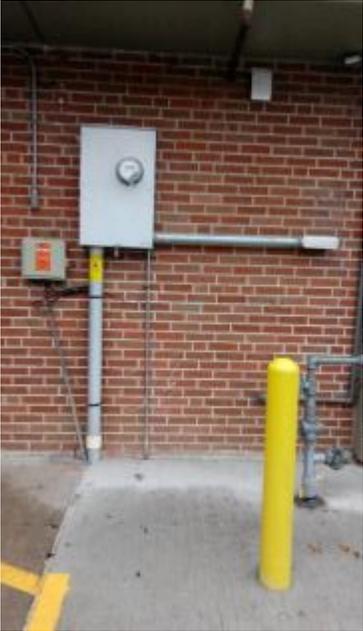
Picture E1

The electrical service to the Administration building is fed underground from utility poles that are located on the north side of the property [Picture E1]. The service comes into the building and feeds a wireway that feeds three panelboards and two disconnect switches in the electrical room [Picture E3]. The service is 240/120V, single phase. The majority of the service appears original to the building with two of the panels appearing to have been replaced more recently. There is an additional utility feed to existing outdoor lighting that is feed from an overhead utility line [Picture E2]. The controls conductors for the fixture appear to enter the building near the existing electrical room. There is a branch panel located in one of the office closets that appears to have been original as well. This branch panel does not have the code required working space due to closet shelving [Picture E4]. There is a second branch panel located in one of the administration offices that is located high on the wall [Picture E5] that used to feed an air conditioning unit in the window but now feeds the water cooler and several office loads. This panel does not have code required accessibility due to the mounting height of the panel. The receptacle feeding the drinking fountain in the hallway is not a GFCI receptacle [Picture E6]. There are no receptacles located in the restrooms near the sinks.

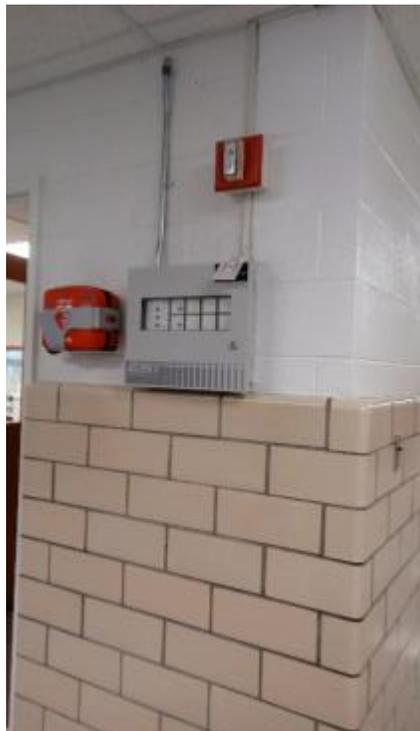
Picture E15

The existing fire alarm panel is located in the hallway near the entrance of the building [Picture E15]. The public restrooms in the building are missing a code required strobe devices. Detectors and horn strobes in the hallways and appear adequate [Pictures E15 through E18].

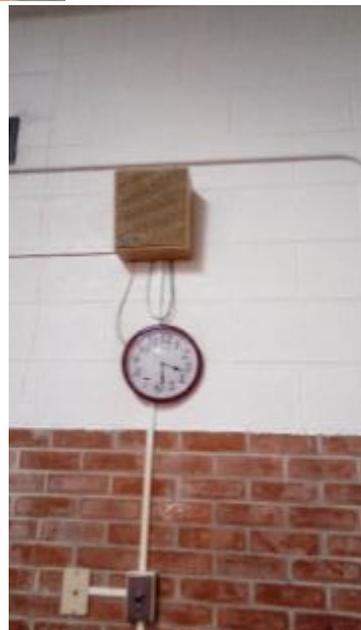
Picture E20

The PA system is a switched Rauland System [Picture E20] that is tied into the original telephone system in the 1950s portion of the building [Pictures E22 through E24]. The school expressed wanting to upgrade to a web based system. In the 1990s portion, they have newer speakers, but they are tied into the existing switched system in the 1950s portion of the building [Picture E21].

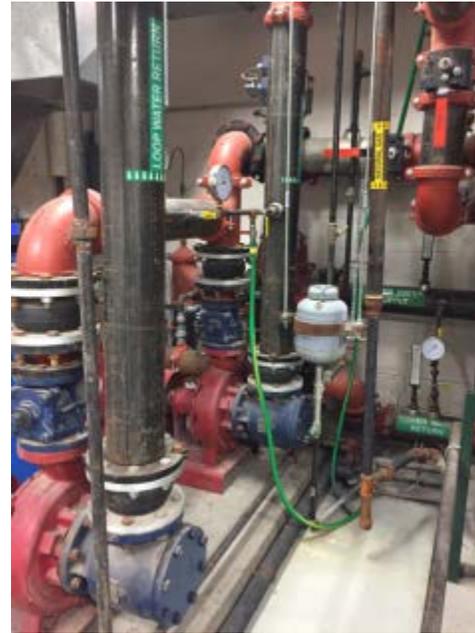
Picture M3

The secondary base-mounted loop water pumps which were replaced in 2008 operate on a lead-lag basis with one in operation and the other a 100% standby. [Picture M3] The pumps are 10 years old. The estimated median service life of this equipment is 20 years. Switchover between the two (2) pumps is manually performed. The pumps do not have variable frequency drives. The pumps circulate water to the various heat pumps.

- b) Replace existing heating water pump motors with new and provide new variable frequency drives to serve the new heating water pumps
- c) Provide neutralizing/ball trap at gas vent drainage prior to discharging to the sewer.

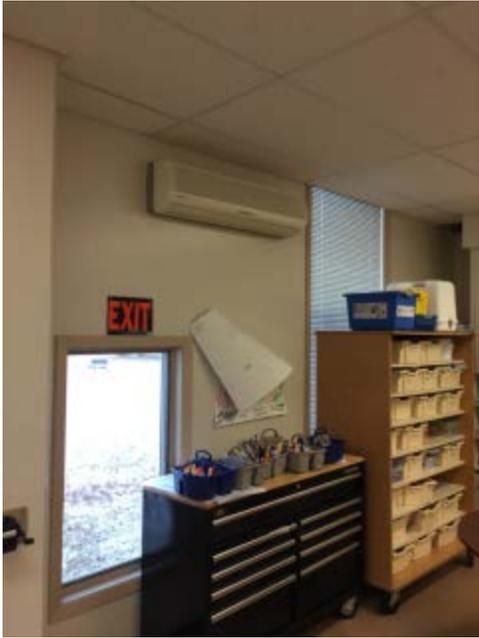
Picture M5

Each classroom is served by a split system (13 total). They were installed at varying times between 1997 and 2018. Each is replaced as they fail. [Picture M5]

- a) Replace existing split systems of the east end of the Elementary School building with new unit ventilators with heating, cooling, and 100% economizer capability
- b) New chiller system
- c) Replace existing unit ventilators of the east end of the Elementary School building
- d) Replace existing recessed cabinet unit heaters in the Corridor
- e) Provide adequate exhaust to serve the Toilet Rooms
- f) Provide new Auditorium air handling units with heating, cooling, ventilating, humidification capabilities
- g) Replace existing heat pumps of the north part of the West End of the Elementary School building

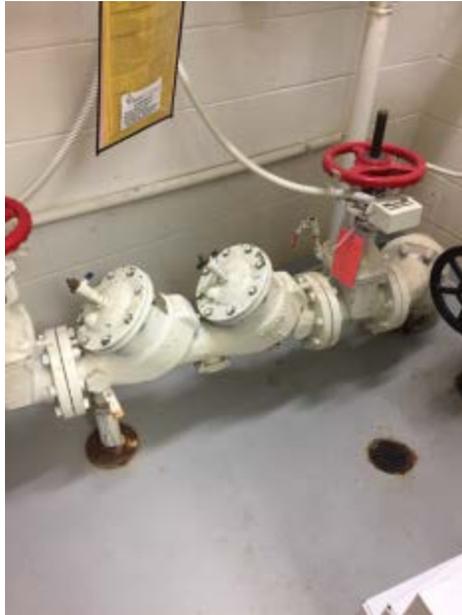
Picture M19

The west end of the Elementary School building is equipped with a fire protection sprinkler system. Incoming service in the Sprinkler Room is provided with a backflow preventer. [\[Picture M19\]](#)

- a) Provide exhaust from the Custodian's Closet
- b) Replace existing plumbing fixtures with new Code-compliant fixtures
- c) Provide a new backflow preventer in the domestic water service

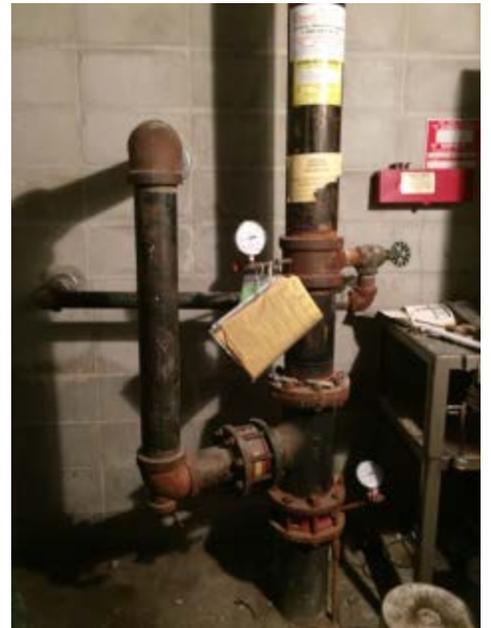
Picture M17

Except for the Auditorium, the High School building is not equipped with a sprinkler system. [Picture M17]

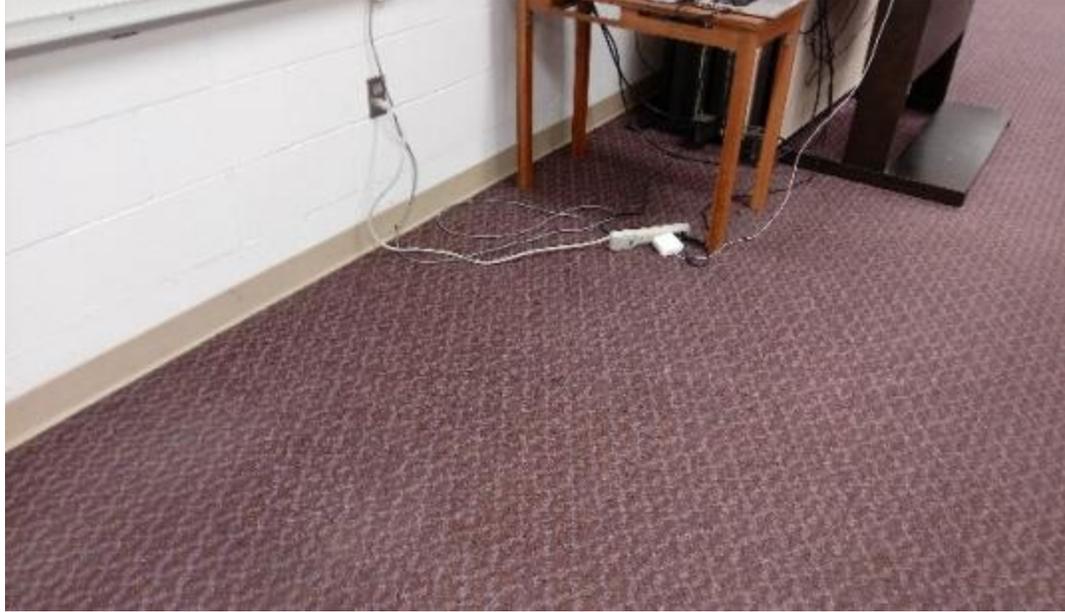
Picture 24

The data appears to be recently renovated throughout the building [Picture E24]. WIFI and data access points were noted as adequate by staff.

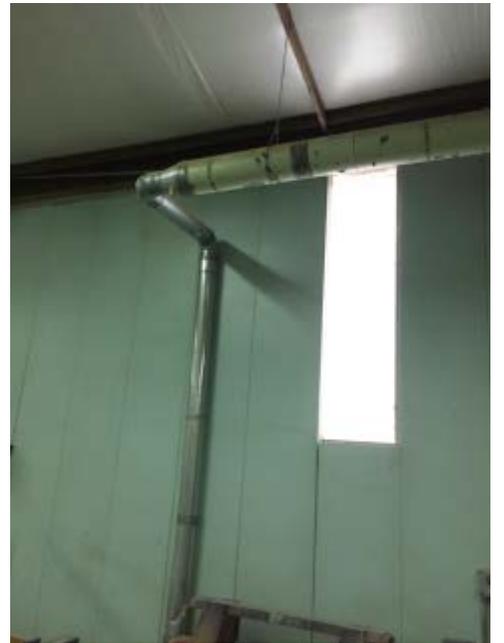
Picture M10

Various gases are located inside the building [Picture M10] along with blowdown of dust from the dust collection system, flammables, and dust accumulation everywhere creates an environment in the woodworking area that is susceptible to fire and explosion.

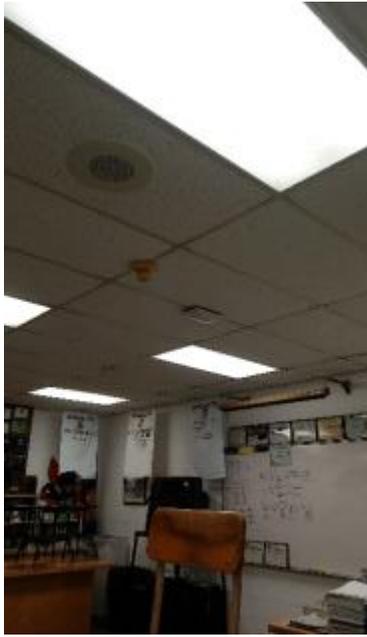
Picture E5

The classroom had WIFI access and it was noted by staff as adequate for the building [Picture E5].
